**GREAT BARRINGTON
COMMUNITY PRESERVATION COMMITTEE**

APPLICATION FOR CPA FUNDING – Step 1

Project Name Preserving the Historic Clinton A.M.E. Zion Church

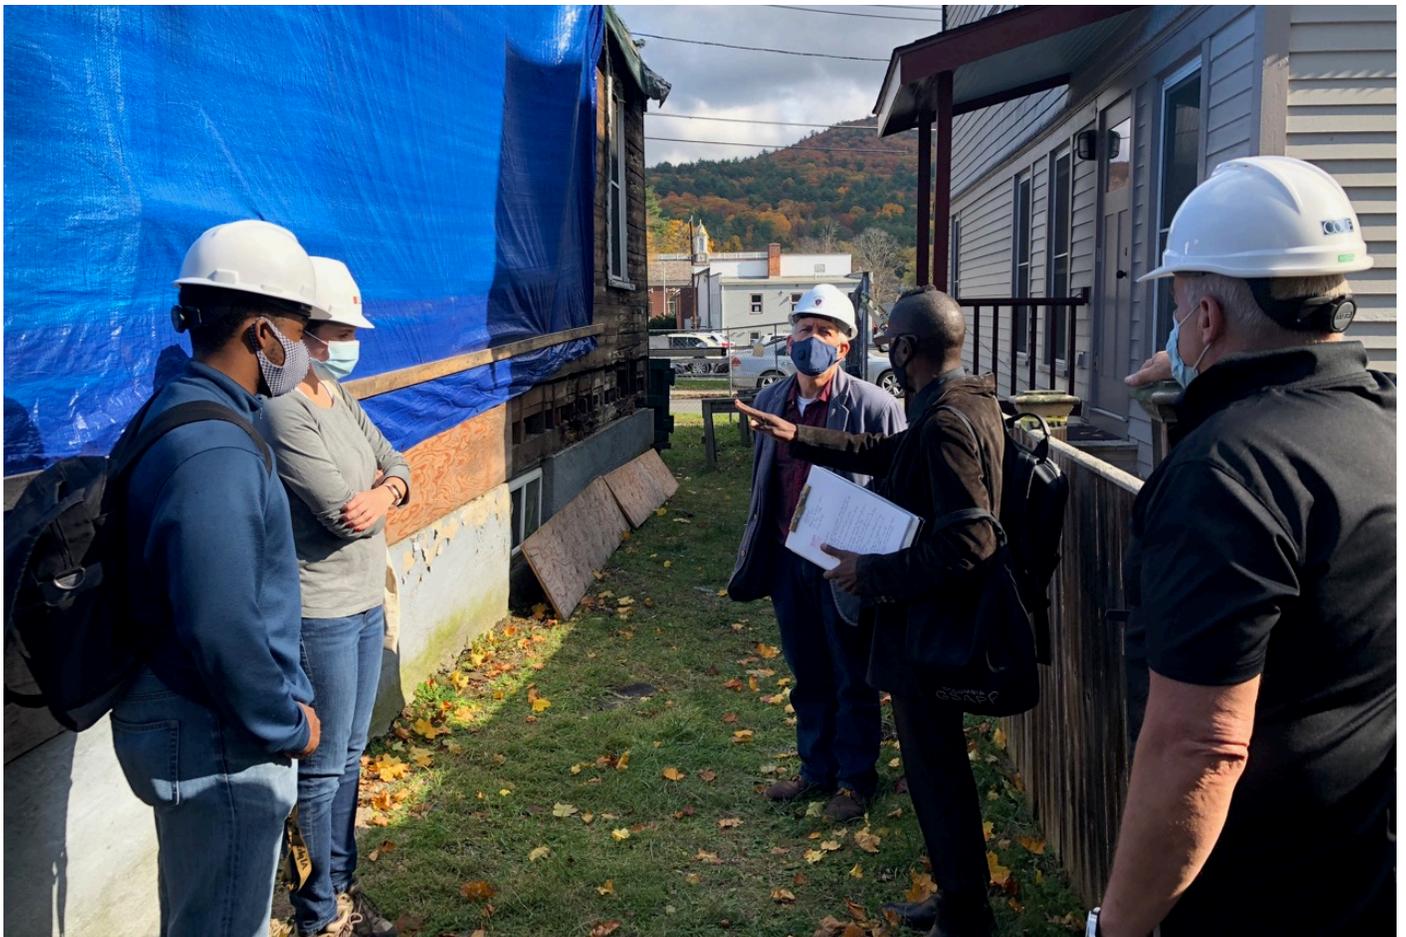
Interior shoring and exterior protection of south sanctuary wall | 10.23.20

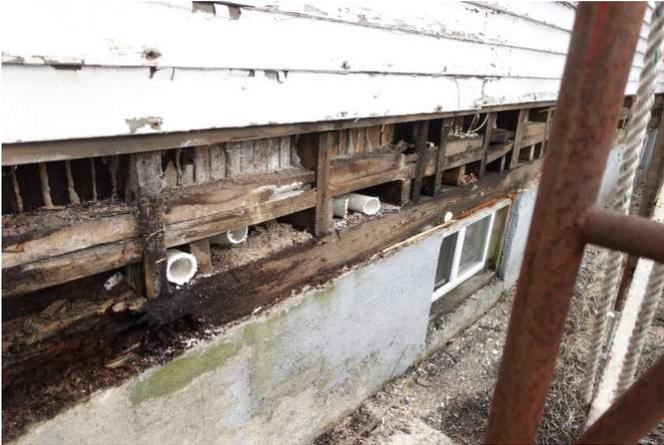
1. As requested, the south wall of the Sanctuary was exposed along the bottom two feet of the wall for the entire length of the wall. (See Figure 1)
2. Approximately one foot of the inside of the wall was exposed to observe the top plate and the studs. (See Figure 2)
3. To test the wood, we used a hammer and 5 in 1 tool to probe soft areas. We also used a drill with a small bit to test resistance when drilling the wood. This was done as a spot check at both deteriorated and solid locations in the wood. (See Figure 24)
4. For approximately 40% of the south wall, the sill plate was observed to be significantly to severely rotted. (See Figures 5 and 6) Overall, about twenty-two feet of the forty-foot length of wall was partially dry and possibly salvageable (See Figure 6) Although it

Figure 1 – Lower zone of deteriorated south wall of the Sanctuary

Based on our observations of the south wall of the Sanctuary, we still recommend immediate shoring be installed to stabilize the south half of the Sanctuary. Silman is working with the contractor to design the shoring. Once shoring is installed, complete removal of the outer cladding should be performed to expose the entire wall for full evaluation. The entire south wall of the Sanctuary should be exposed for further evaluation.

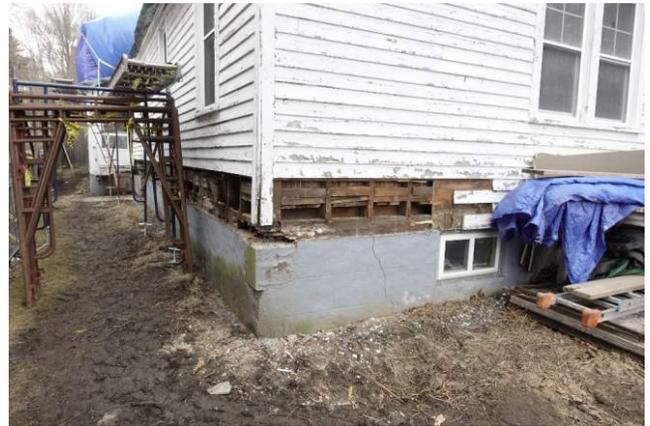
appeared to be dry, there is likely additional defects in the center of the wood due to ongoing water damage and insect damage. The bearing ends of the floor joists that bear on the bottom sill plate were visibly rotted in areas that were actively wet. (See Figures 25, 26, and 27) While on site we requested the probe at the base of the wall wrap around the east wall. The southeast corner framing at the base was completely missing but about a couple feet east of the corner, the wall was observed to be dry. About 6 feet of the base along the east wall was exposed. As noted above, even though the wood was observed to be dry does not mean that it does not have internal damage not yet observed. (See Figures 3 and 4)

Figure 4 Overall view of southwest corner of Sanctuary

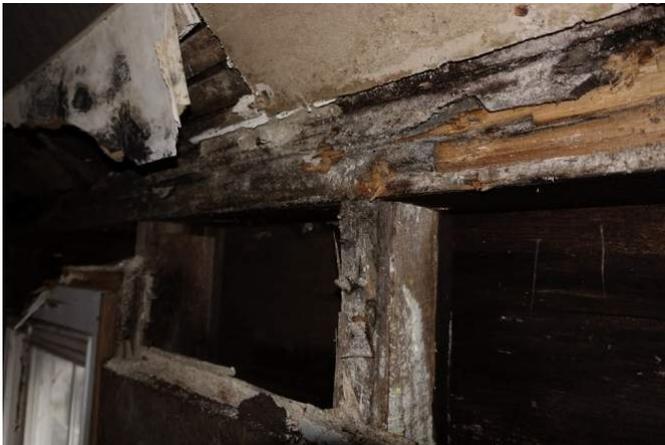
7. We drilled the upper 10" of studs and found about half were rotted or hollowed out by insects. (See Figures 2 and 7).
8. We anticipate 100 % of the upper half of the double top plate requires replacement and possibly 25% of the bottom half. Given the top plate is a double plate and nailed together, it will likely make sense to replace it entirely. Some portion of the rafter ends will require sistering, but it is too early to estimate how many rafters need sistering until we observe them from above.

Figure 2 The inside of the south wall of the Sanctuary exposing the top plate and studs below

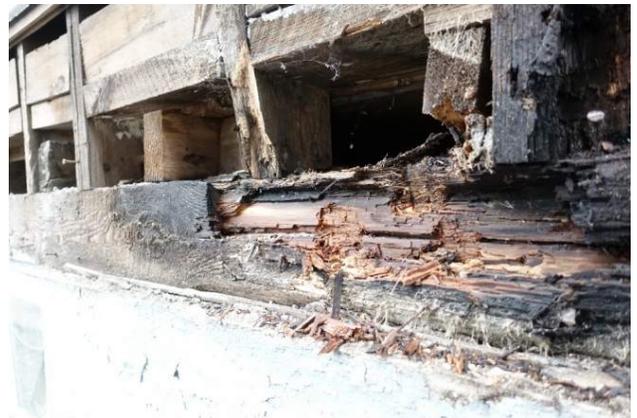
Figure 5 Close up of highly deteriorated base of south Sanctuary wall

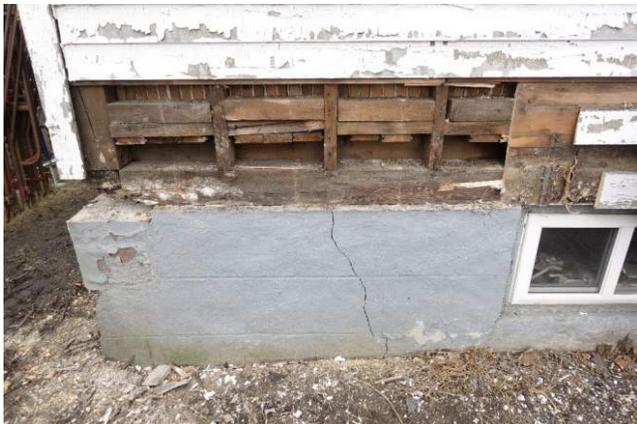
Figure 3 Overall view of the south wall of Sanctuary wall exposed. The damage is contained to the west corner. Note the crack in the foundation wall that should be further evaluated.

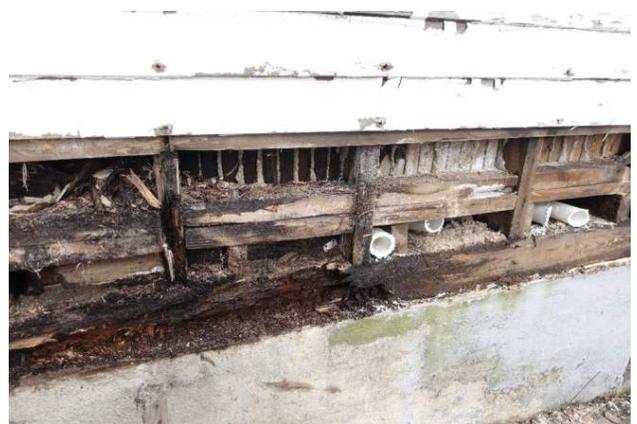
Figure 6 Transition zone where highly deteriorated wood becomes dry to the right side of photo, left side of photo is west end of Sanctuary with extensive rot.

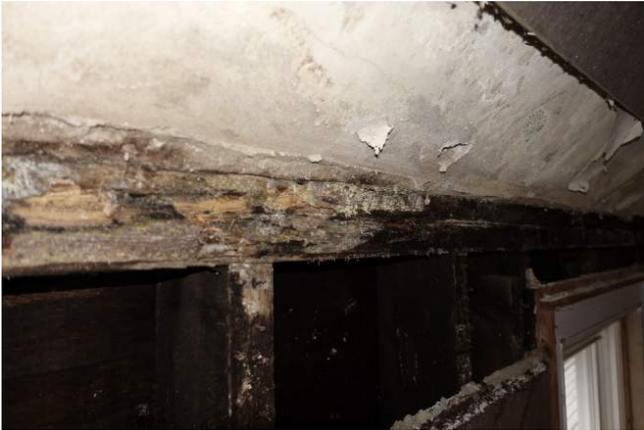
Figure 7 Top of south side of Sanctuary from inside- note saturation and mold

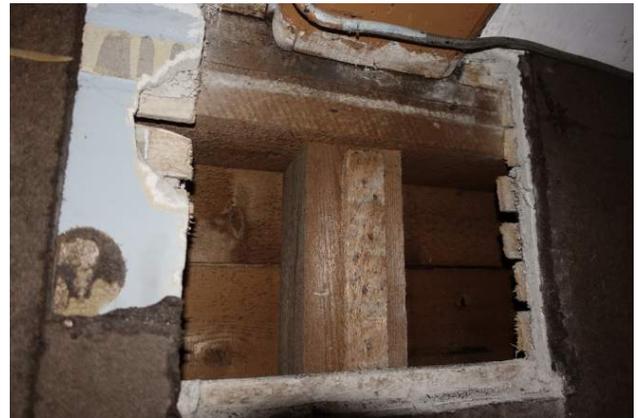
1. While documenting probes on the north wall we noted the northwest corner of the Sanctuary was dry at the base and top of the wall. (See Figures 8 and 9)
2. At the western truss we noted insect damage at the base of the support post. (See Figures 10 and 11)

Figure 10 top of western truss on north wall of Sanctuary- wood is dry

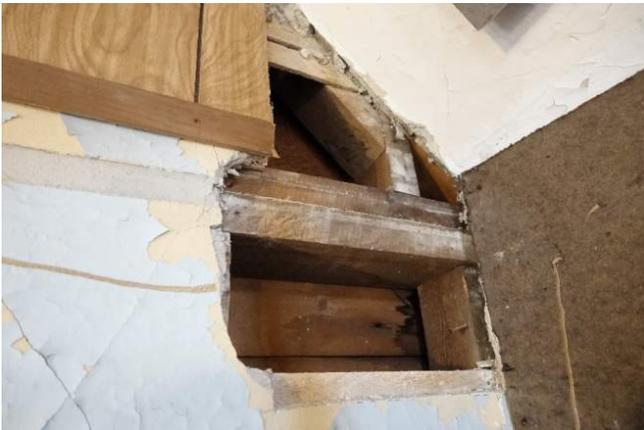
Figure 8 Top northwest corner of Sanctuary on north wall- wood is dry

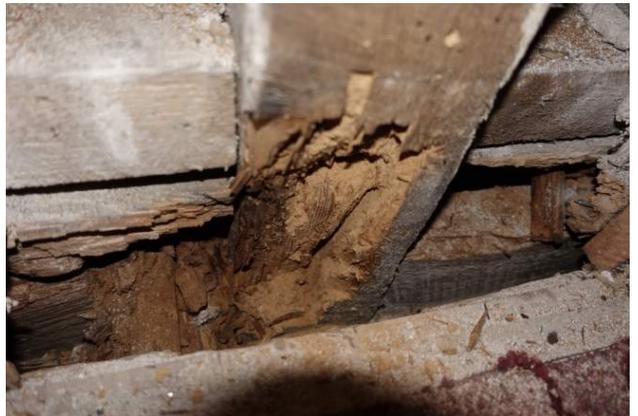
Figure 11 Base of western post that supports the truss on north Sanctuary wall was highly damaged by insects.

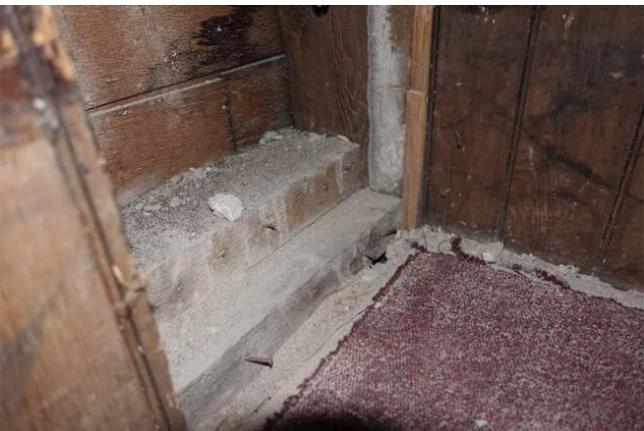
Figure 9 Base of northwest corner of Sanctuary- wood is dry. We only observed the inner face of the 6x6 post. The back side of the wall has exterior sheathing visible as this was an exterior wall originally.

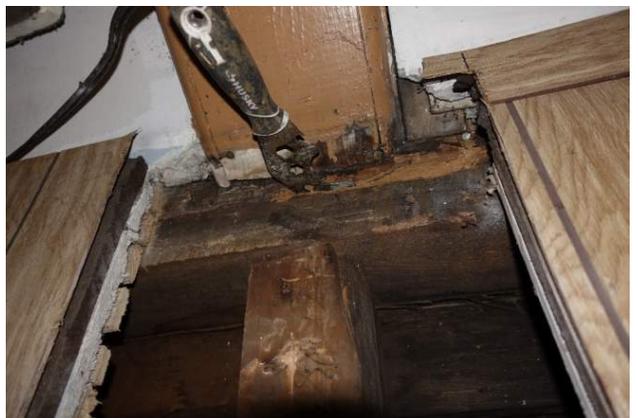
The roof rafters span north south and bear on the exterior wall top plate, with no ridge board or beam in the ridge of the sanctuary roof framing. The scissor trusses are the primary components for resisting the lateral thrust of the roof framing. The roof scissor trusses are supported on 4"x5" wood posts buried within the wall. We found those to be soft below the top plate when drilled as well. (See Figure 12)

3. At the most eastern truss we observed the top plate was deteriorated under the bearing of the truss and to the east of the truss. (See Figure 12)
4. At the base of the support post for the truss, we observed a previous repair had been done that included cutting out and rebuilding the base of the wall for about 20'-0" and 18" high. (See Figure 13)

Figure 12 Top of eastern truss on north Sanctuary wall with significant insect and moisture damage

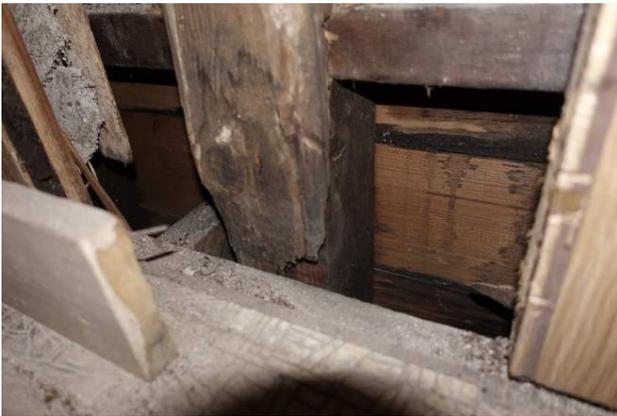
Figure 13 First view of base of post that supports eastern truss on north Sanctuary wall. This prompted us to expand the probe. The post has been cut and a repair using 2x6 has been inserted.

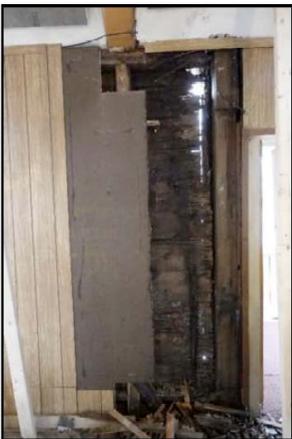
5. To the east of the probe we saw daylight coming through the wall. As a result, we requested a full height removal of inner finishes of the wall about 4' the east of the east truss. Two studs crumbled upon removal of inner finishes, all that was left was highly deteriorated sheathing. (See Figure 14)

Figure 14 Larger probe performed to uncover 2 fully rotted studs that crumbled upon removal of plaster. Note daylight coming through the wall.

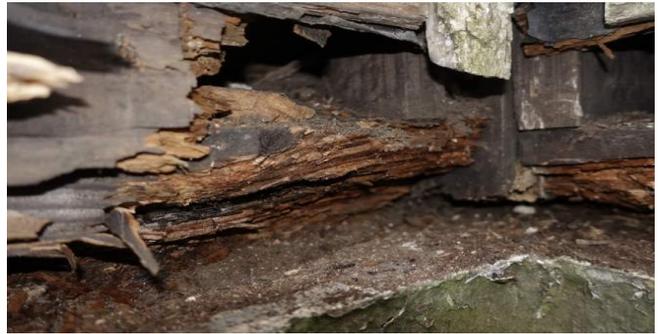
6. This area is where the entry vestibule (Narthex) frames into the north wall of the Sanctuary. We removed some highly deteriorated cladding in the reentrant corner outside. We observed that the 6" base plate was only 3" high here. It was rotted and compressed three inches. (See Figures 15 and 16)

Figure 16 Close up of Narthex deteriorated base plate

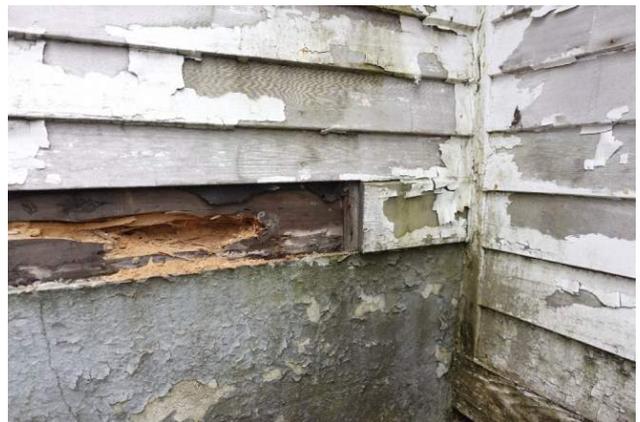
Figure 17 Base of wall next to basement entry vestibule

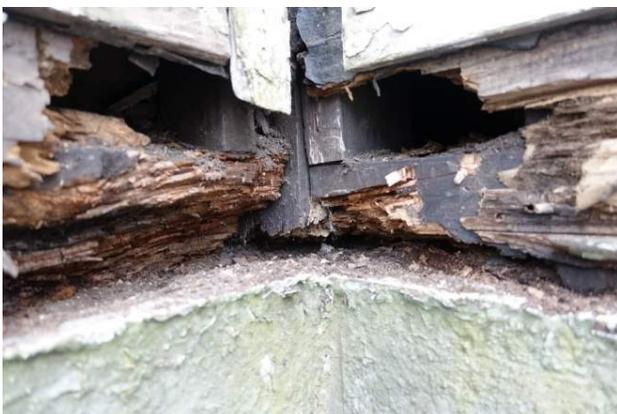
Figure 15 View of exterior corner between Narthex and north wall of Sanctuary. Note the degree of rot in the base plates here.

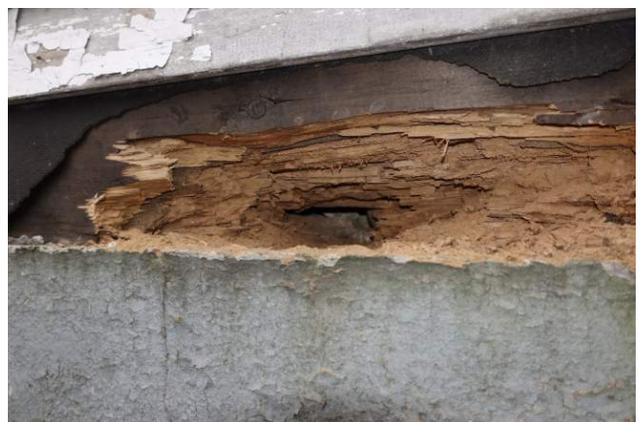
Figure 18 The rot in the base plate traveled through to the inside of the basement.

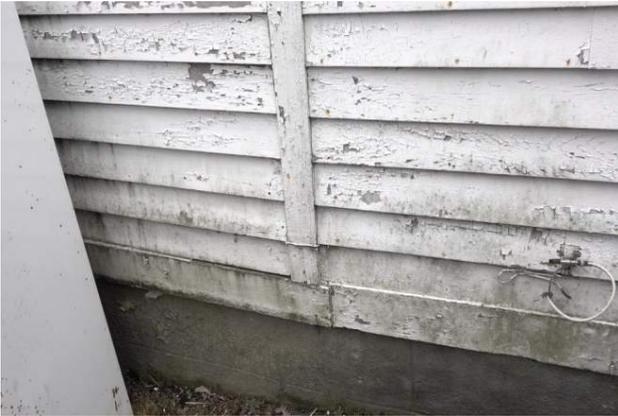
9. West of the basement entry along the exterior base of north wall, we noted the wood was soft when probed as well but did not perform any removals. (See Figure 19)

Figure 19 Transition between 1886 and 1890's where base of north wall had deterioration behind sheathing.

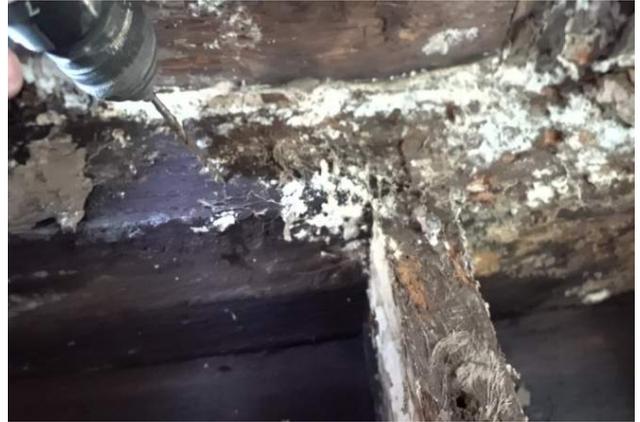
3. The eastern end of the wall has two replaced 2x6 studs and a new 2x6 base plate installed over the original base plate. (See Figure 21)
4. All 6'-2" of the 1939 addition base plate was soft and saturated. The (5) 2x6 studs of the 1939 addition were saturated and beginning to rot. (See Figure 22)

Figure 22 West end of 1939 addition top of wall with extensive rot

We recommend either significant localized rebuilding or complete rebuilding of the southwest exterior wall. Saving historic fabric will be more time consuming and expensive than a complete rebuild, but there are important aspects of the framing that will be lost in the complete replacement. We can proceed with either repair campaign.

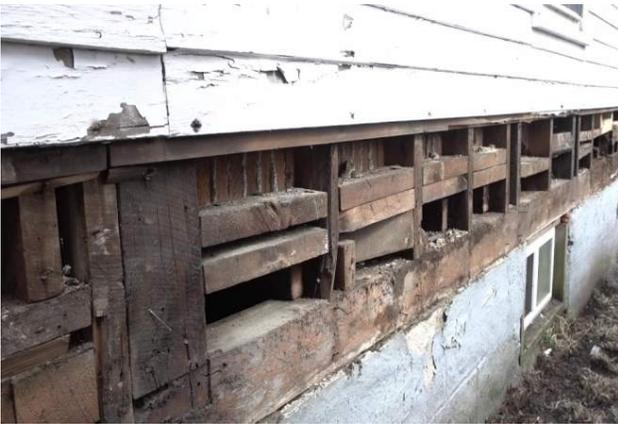
1. Silman reviewed the exposed structural conditions of the base and top of the south wall where Phase 1A work is currently underway. (See Figure 20)
2. About 5'-0" of base of the 1886 wall was highly deteriorated. The remaining 11'-0" was reasonably dry but there is likely additional defects in the center of the wood due to ongoing water damage and insect damage. (See Figure 21)

Figure 20 Overall view of southwest corner of south wall (west wing). The 6x6 post in the foreground is the end of the original 1886 building. The left corner shows the beginning of the 1939 addition

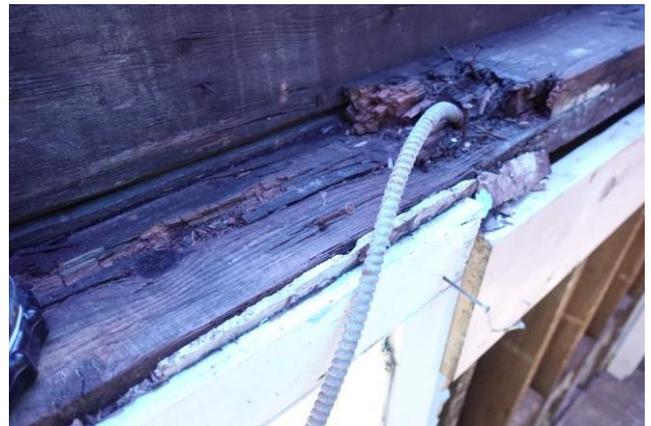
5. The top double plate of both eras of construction was highly deteriorated. The top plate was mostly gone. Studs below the top plate were easy to drill into indicating internal rot or insect damage. (See Figures 23 and 24)

Figure 23 Top of 1886 south wall (west wing) with joists already removed.

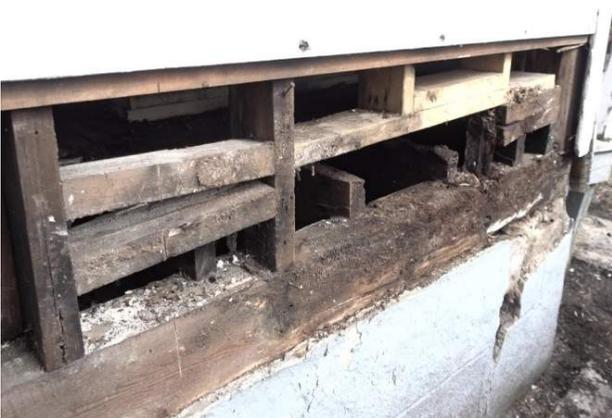
Figure 21 Part of southwest corner of building at west wing. Combination of rotted and dry wood. You can see the two replaced studs.

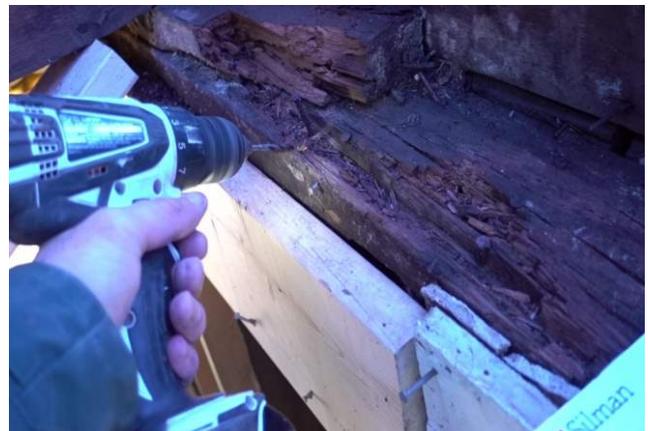
Figure 24 Close up of top of west wall being drilled for resistance.

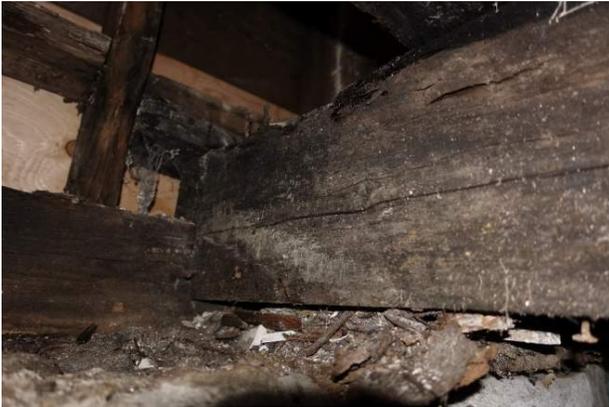
Figure 25 View of a joist notched to bear on top of 6x6 base plate. The bearing end is often in very poor condition.

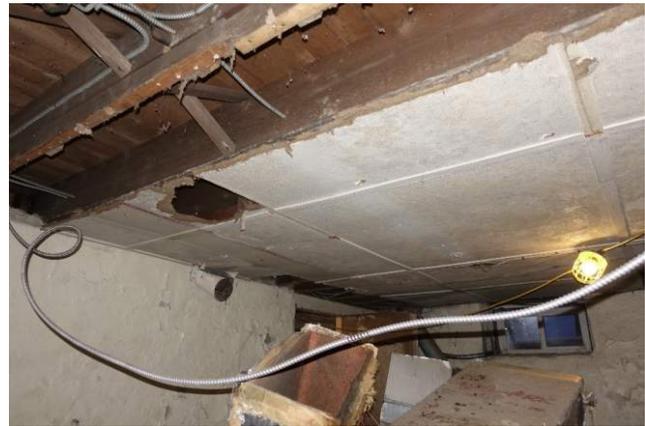
Figure 28 Area in northeast part of Sanctuary that had not yet been uncovered

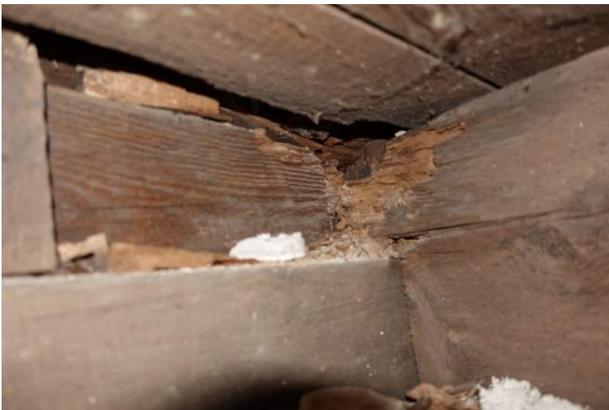
Figure 26 Close up of highly deteriorated joist where it bears on the base plate of the north wall.

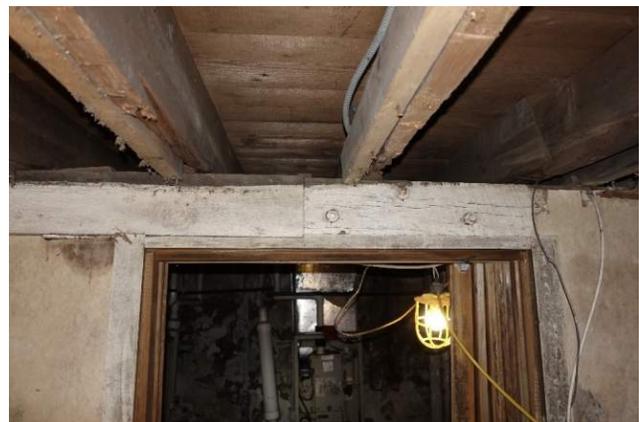
Figure 29 This is a view of the half lapped joint in the center 6x6 wood girder located over the doorway into the kitchen.

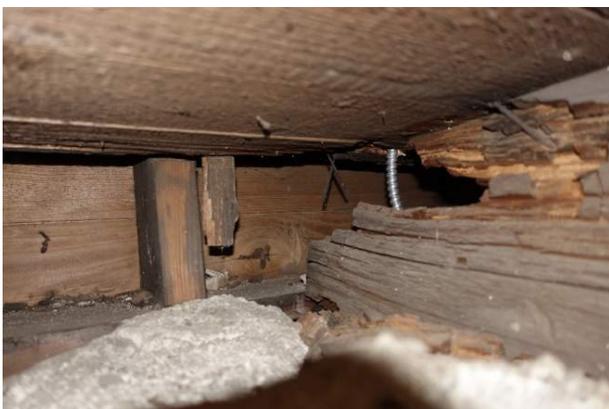
Figure 27 Another view of a fully rotted out joist, the wall framing visible here is the repair wood inserted along the north wall

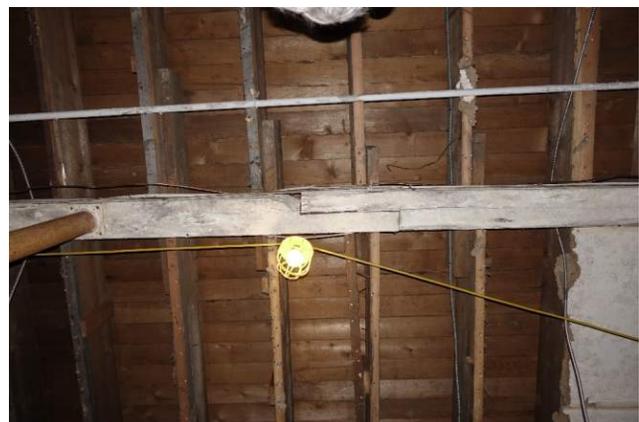
Figure 30 View looking up at half lap joint

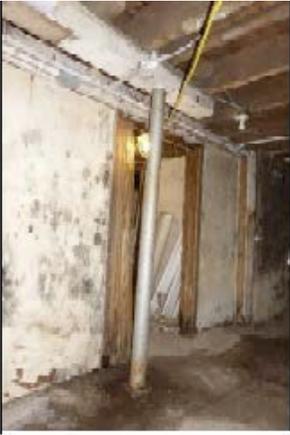
Figure 31 View of the 2nd wood girder that is south of the main wood girder. The door opening visible is to the kitchen. The girder starts at the west 1886 foundation wall and ends at the post visible in this photo

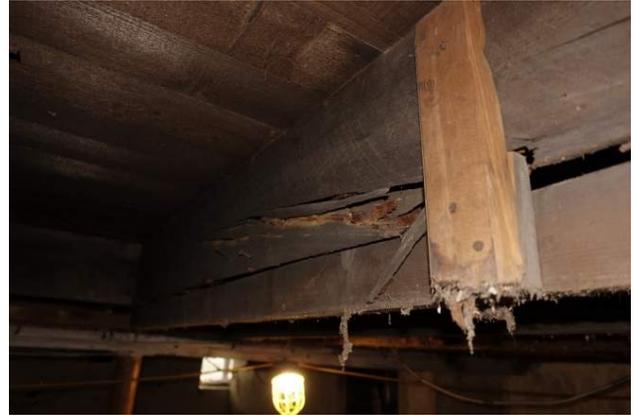
Figure 34 This fully failed and rotted joist is the northwest trimmer for this headered condition

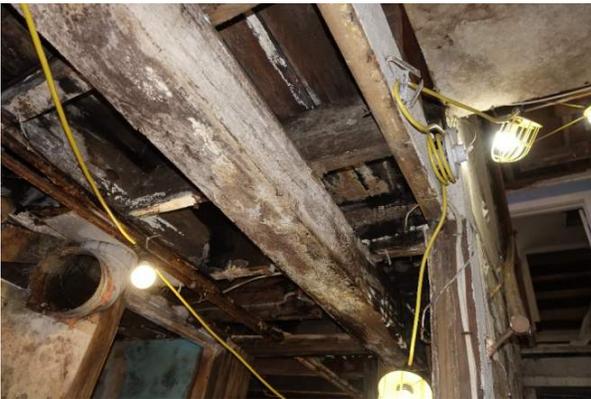
Figure 32 This is the 3rd wood girder, south of the staircase that starts at the west 1886 foundation wall and ends on the chimney masonry pier

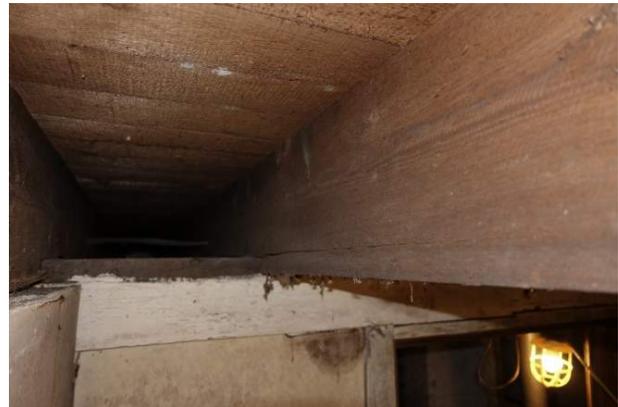
Figure 35 Kitchen joist that is notched to go over 6" x 6" wood girder because it is 8 1/2" high

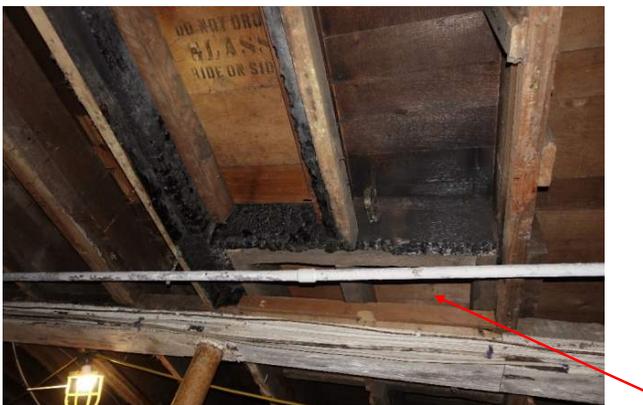
Figure 33 Location of earlier hole in the Sanctuary floor about 24' x 26" wide – two spanning joists are headered off at the opening. At this location, 30" of the 6" x 6" wood girder had been cut out. Due to this cutout, the 6" x 6" girder is cantilevering off the post to the east about 2'-0"

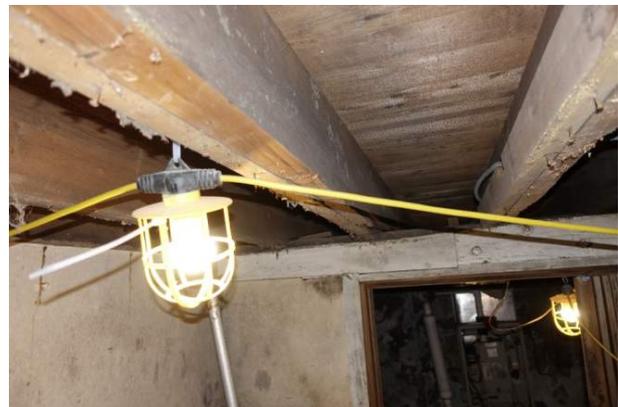
Figure 36 Bottom of joist was cut crudely along its bottom, possibly because it was too low for the ceiling

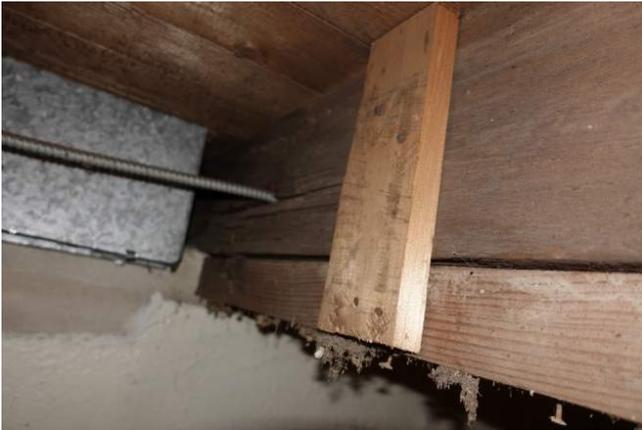
Figure 37 blocking installed in much of the main Sanctuary, possibly to align with the bigger joists in the kitchen when the ceiling was installed. Prior to ceiling panels being removed, this blocking gave the impression the 6" x 6" wood girder was smaller than it is. The joists are more commonly 7 1/2" high

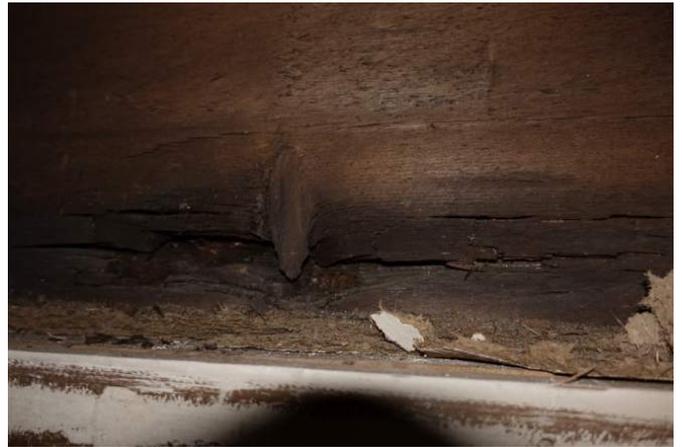
Figure 40 Insect and/or water damage to joist

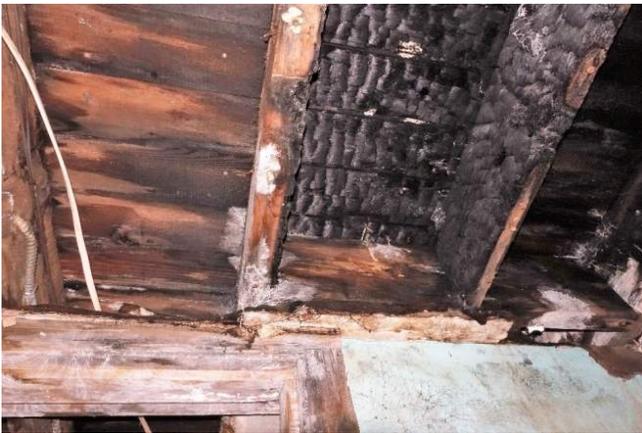
Figure 38 Burned joists

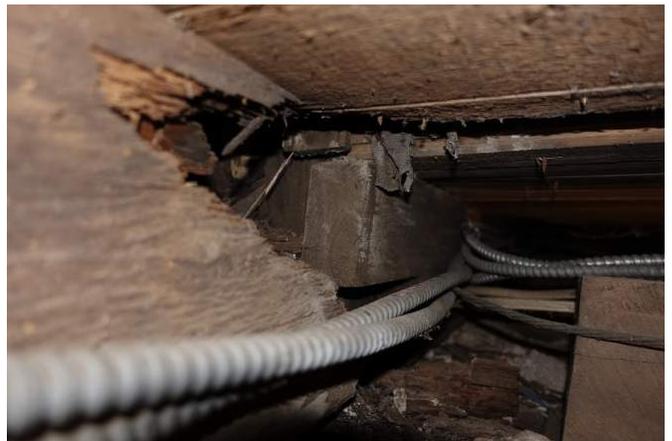
Figure 41 Joist end along north wall-possibly water or insect damage, or both. This is above the wood header between the main Sanctuary and the Narthex. The wood visible beyond are the Narthex joists

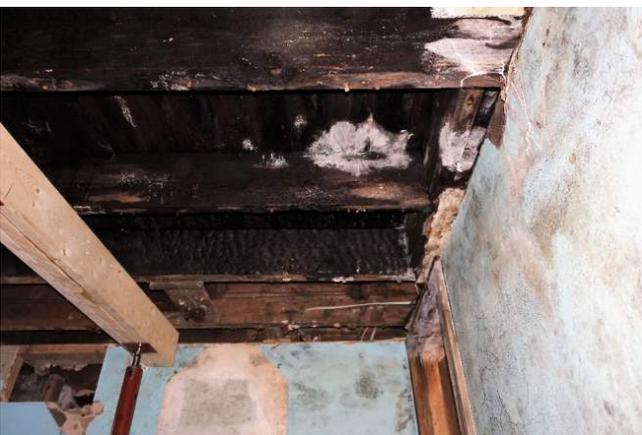
Figure 39 another view of burned joists

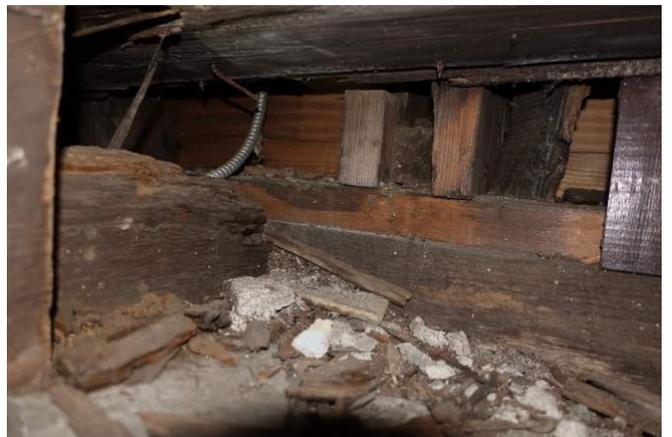
Figure 42 This is view between two joist bays in the Narthex. The rebuilt wall is visible beyond and the end of the joist is fully rotted away. The edge of wood visible at the far left of the picture is a sister joist

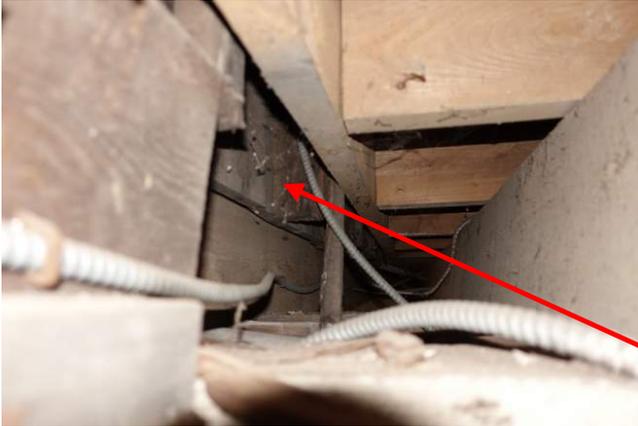
Figure 43 This is a view of the raised floor built on top of original joists under the Apse. The arrow points to wall framing that appears to have no bearing. This needs further evaluation

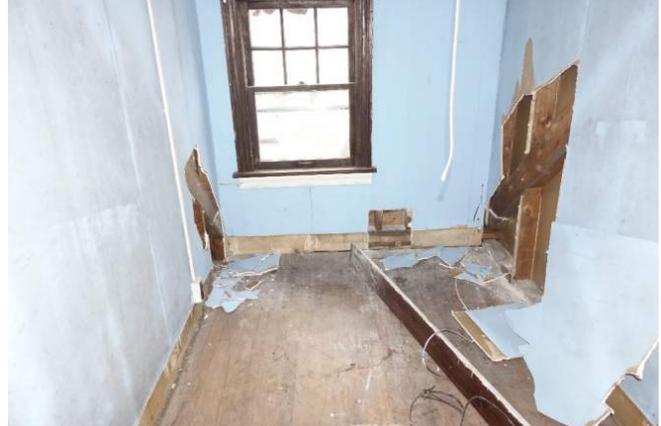
Figure 46 Overall view of the 2nd floor room with both walls being built around the double rafters

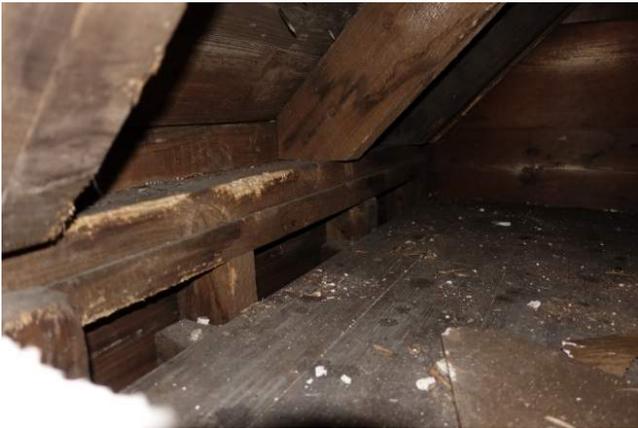
Figure 44 View of the balloon style framing used on the north half of the 1890's addition. You can see the 2nd floor joists below the floorboards about three inches lower than the bottom side of the double top plate of the wall and rafters bearing on the top side.

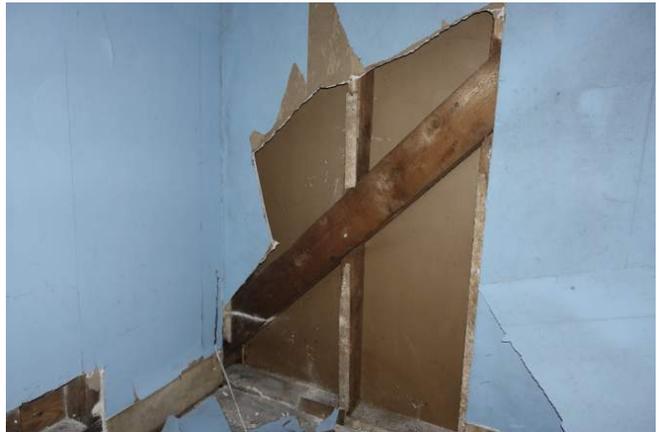
Figure 47 Close up of double roof rafter passing through the wall and studs built to it.

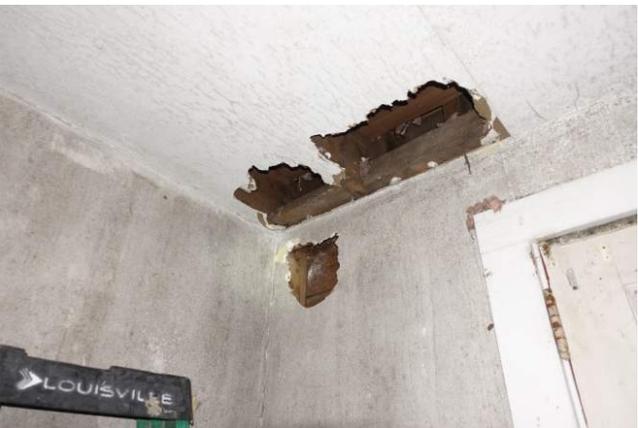
Figure 45 View from the 1st floor ceiling along the north wall of the west extension. The wood between the joists is just a nailer for the ceiling. The joists are nailed to the side of the studs

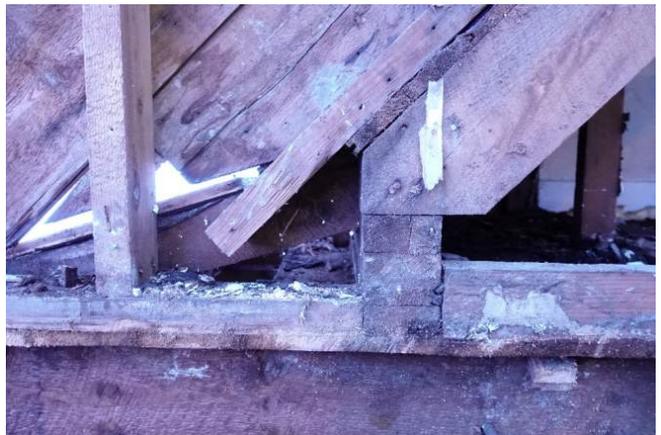
Figure 48 Western end south dormer and its connection to a triple plate that bears on 2nd floor joists. Beyond to the left is the 2x4 extension of the roof rafter that travels another 4 feet to the top plate of the south exterior wall.

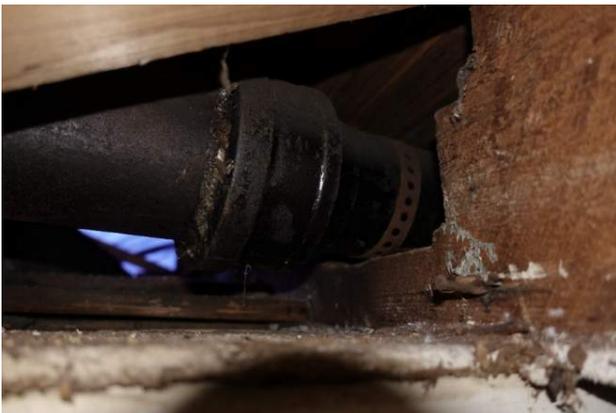
Figure 50 Cut joists below the bathroom and its cast iron bathtub. At last three were observed to be cut to the point the joists cannot hold weight

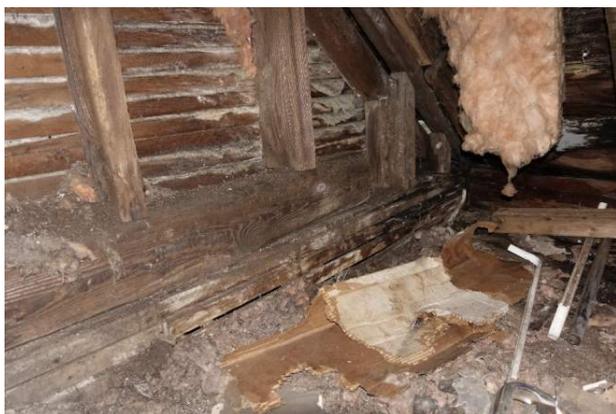
Figure 51 Inside closet toe h south of the chimney at the 2nd floor. You can see the plaster wall that is the interior of the Sanctuary. There is an embedded double plate that framed the gable end of the sanctuary. You can see the wood is deteriorated.

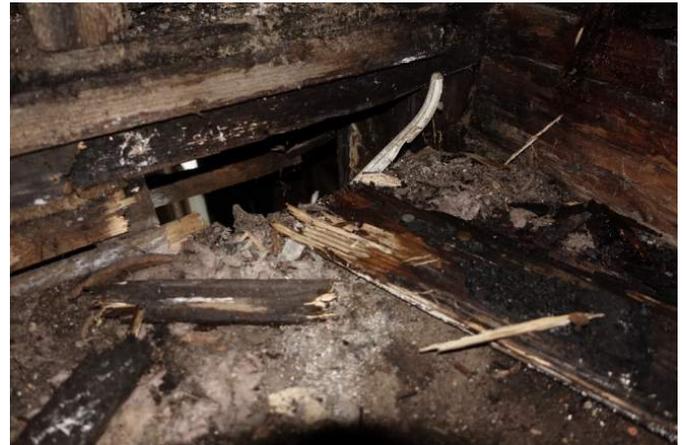
Figure 52 This is close up of the corner where you can see through the wall. The concern is if this part of the wall is this damaged, the header over the Apse needs to be observed for intactness

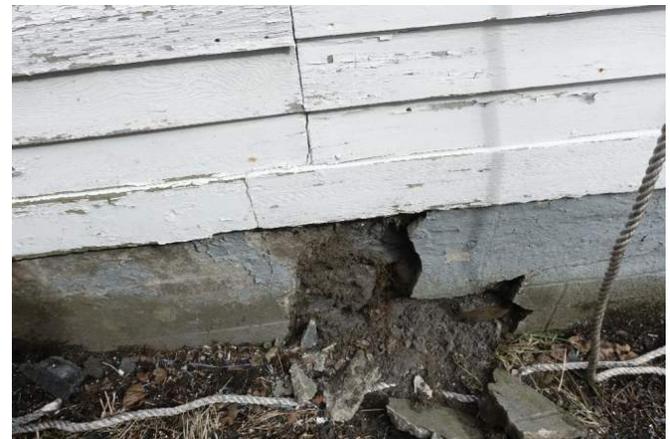
Figure 53 Foundation wall disintegrating behind the stucco finish

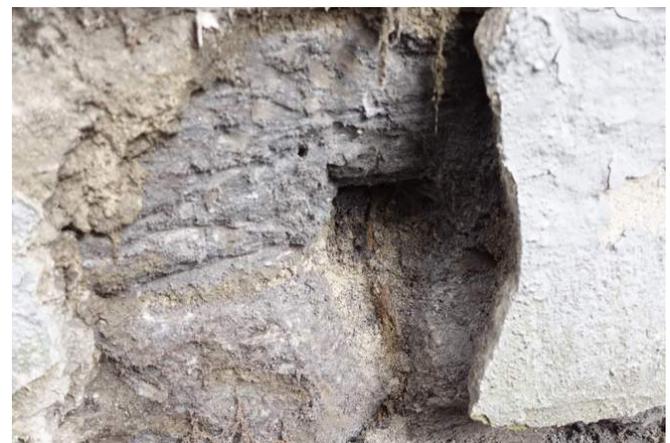
Figure 54 A close up of the wall indicates the grey loose, wet, and sandy material may be coming from this grey colored stone. The Church in town is built of a very similar stone.

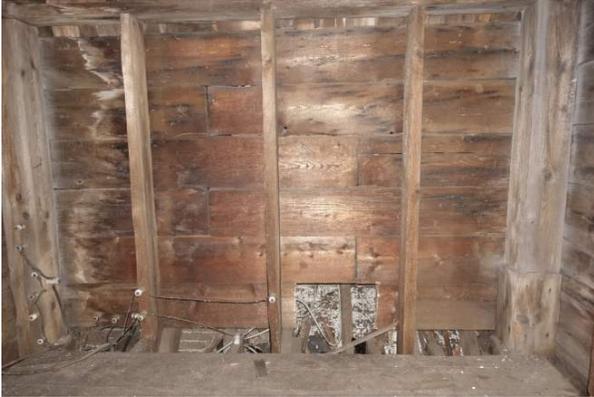
Figure 55 Inside the attic space above the entry and below the bell tower. Each corner is a 6" x6" post that travels through the framed assembly. This is looking south; you can see the ceiling of the Sanctuary beyond

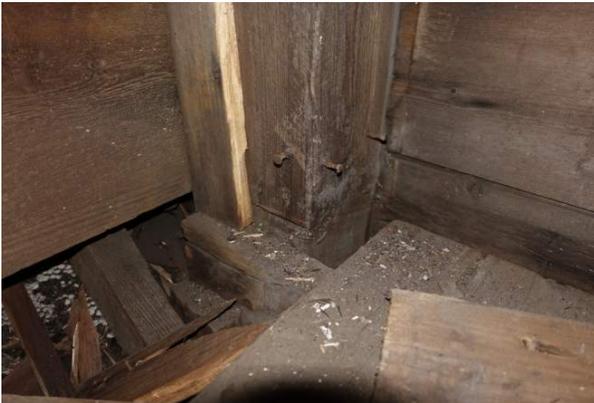
Figure 56 Close up of post just above the 2nd floor level, where a butt joint that was hidden behind two boards nailed to the post is now visible. This is a hinge point in the column assembly.
