## WATERSHED-BASED PLAN

Lake Mansfield  
Great Barrington, MA

December 5, 2018

Lake Mansfield Improvement Task Force  
Great Barrington Planning Department  
Lake Mansfield Alliance  
Geosyntec Consultants, Inc.

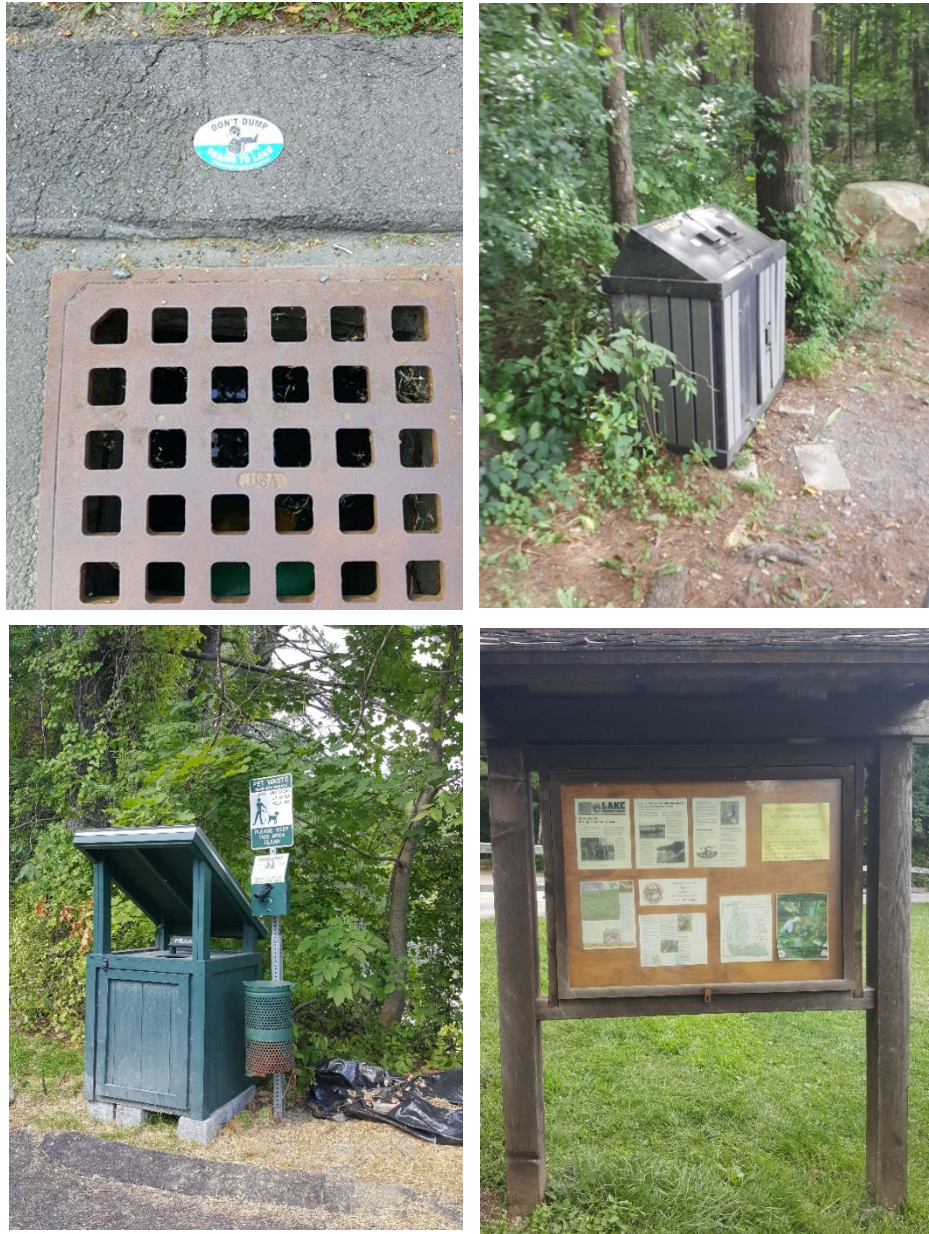
**Figure E-1: Existing Examples of Public Education and Outreach in the Lake Mansfield Watershed**

3. There are currently three kiosks (Recreation (beach) Area, Boat Launch and at trail heads) that contain informational signage
4. Bear proof trash bins; dog waste bags and bins; and baby changing stations are all available at the Recreation Area.

5. Perform Annual Lake Mansfield Cleanup. This has been a successful event with approximately 30 volunteers participating for the last eight to ten years.

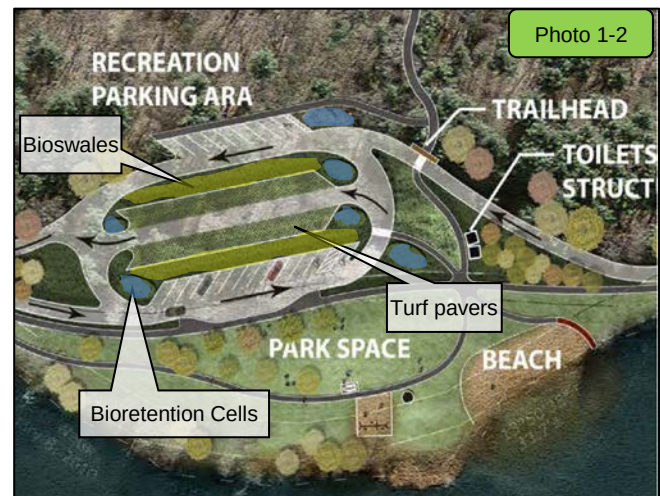
## Site 2: Emergency Vehicle Parking\*

BMP Type: Swale, Rain Garden, and Grass Pavers

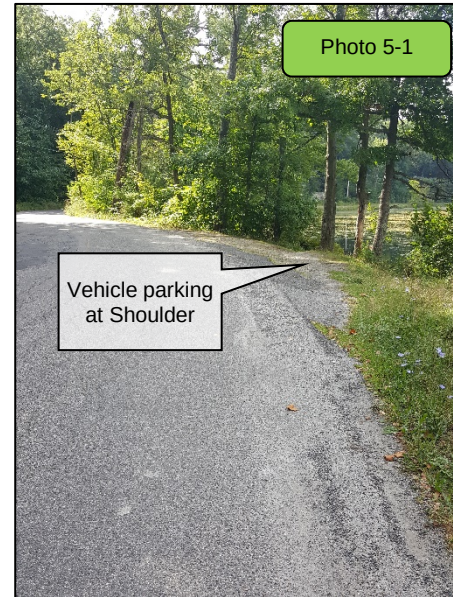
## Site 6: Boat Launch

**BMP Type:** Bioretention Cell
